# Manhole Inspection Summary

Manhole # S13II\_050MH

Insp Date: **11/1/07 11:24 AM**

**Location** Address: **2737 ASHBURTON ST**

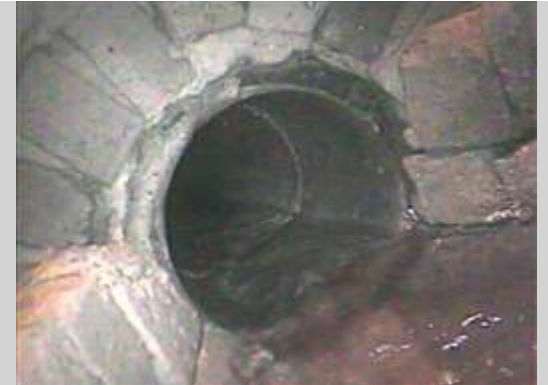
12 O'Clock Outflow

8 in. Circular Gravity Sewer  
Pipe Out @ 12 O'Clock

Pipe Material: **Clay** ☐ Pipe Lined

Invert Depth: **15.43** (ft.) Flow Characteristics: **Slow**

Deposits: ☒ None ☐ Mud ☐ Sludge ☐ Debris ☐ Grease

Infiltration: **None** Pipe Seal Cond: **Sound**

Connects To: **Manhole**

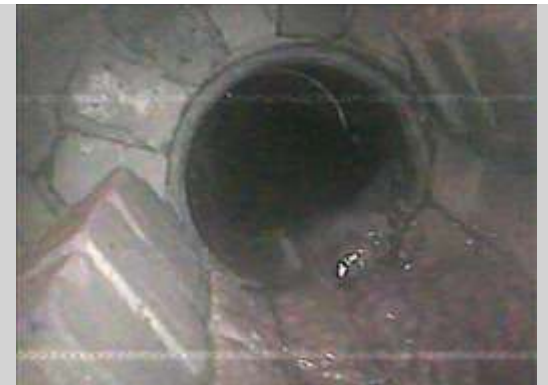
2 O'Clock Inflow

8 in. Circular Gravity Sewer  
Pipe In @ 2 O'Clock

Pipe Material: **Clay** ☐ Pipe Lined

Invert Depth: **15.39** (ft.) Flow Characteristics: **Slow**

Deposits: ☒ None ☐ Mud ☐ Sludge ☐ Debris ☐ Grease

Infiltration: **None** Pipe Seal Cond: **Sound**

Connects To: **Stub connection / abandoned**

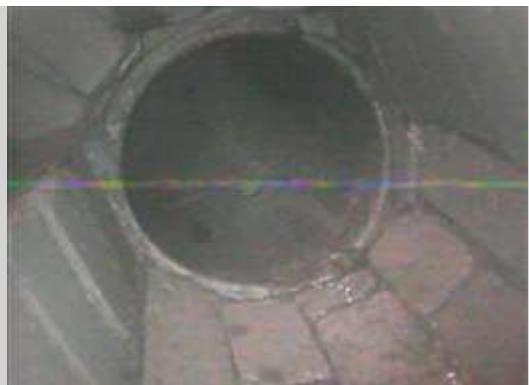
6 O'Clock Inflow

8 in. Circular Gravity Sewer

Pipe In @ 6 O'Clock

Pipe Material: **Clay** ☐ Pipe Lined

Invert Depth: **15.24** (ft.) Flow Characteristics: **Slow**

Deposits: ☒ None ☐ Mud ☐ Sludge ☐ Debris ☐ Grease

Infiltration: **None** Pipe Seal Cond: **Sound**

Connects To: **Manhole**
